**NIST NCSTAR 1-5A** Federal Building and Fire Safety Investigation of the World Trade Center Disaster

## Visual Evidence, Damage Estimates, **And Timeline Analysis**

(Appendices D-G)

## Appendix D WTC 1 EAST FACE COMBINED FIRE AND WINDOW CONDITION AND WINDOW SMOKE CONDITION

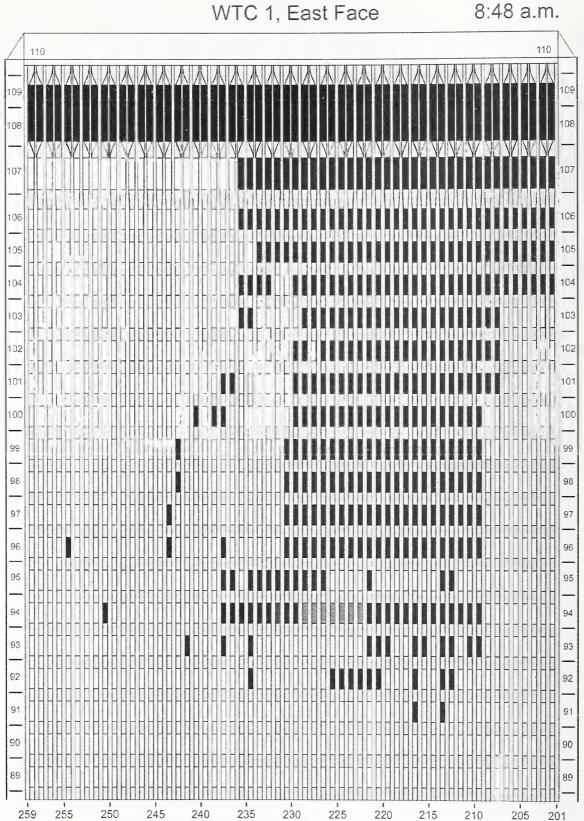
Figure D-1. Diagram of the east face of WTC 1 for floors 89 to 110 at 8:48 a.m. showing the condition of windows and locations of fires.

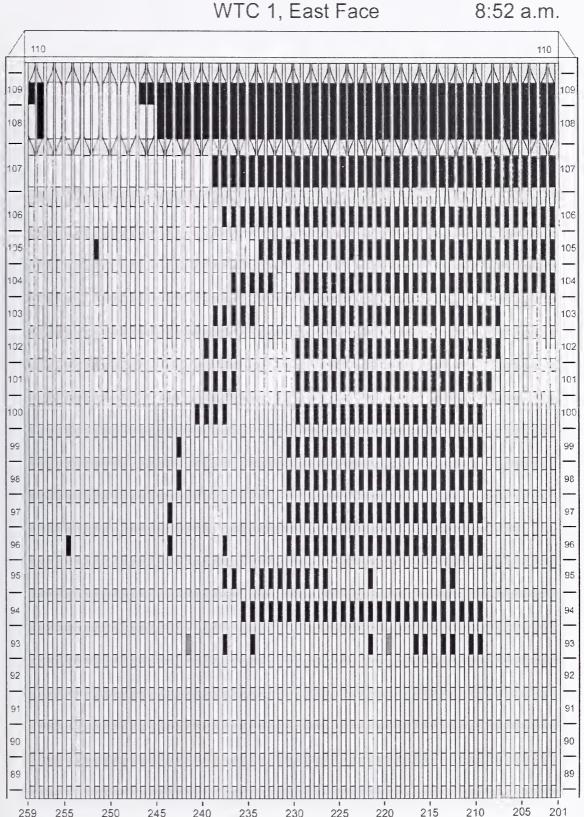
Figure D-3. Diagram of the east face of WTC 1 for floors 89 to 110 at 8:52 a.m. showing the condition of windows and locations of fires.

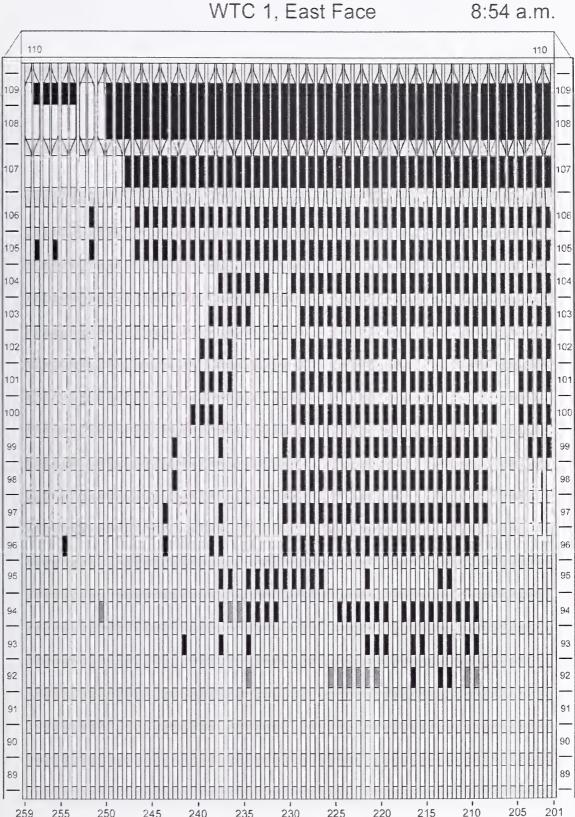
Figure D-5. Diagram of the east face of WTC 1 for floors 89 to 110 at 8:54 a.m. showing the condition of windows and locations of fires.

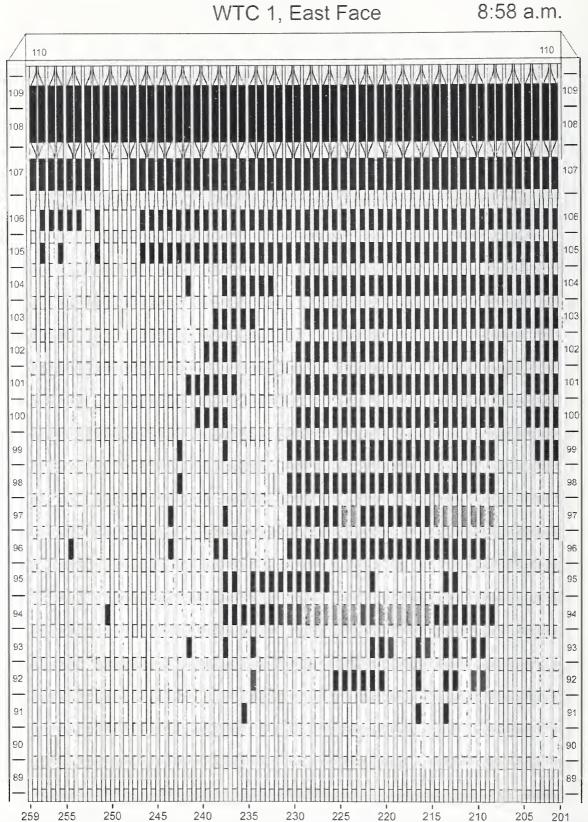
Figure D-7. Diagram of the east face of WTC 1 for floors 89 to 110 at 8:58 a.m. showing the condition of windows and locations of fires.

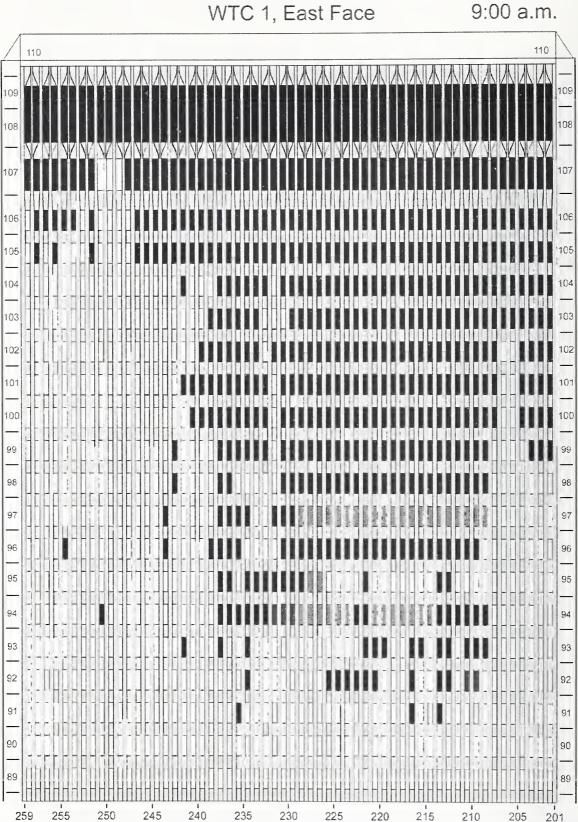
Figure D-8. Diagram of the east face of WTC 1 for floors 89 to 110 at 8:58 a.m. showing windows where smoke was observed and those that were hidden from view.

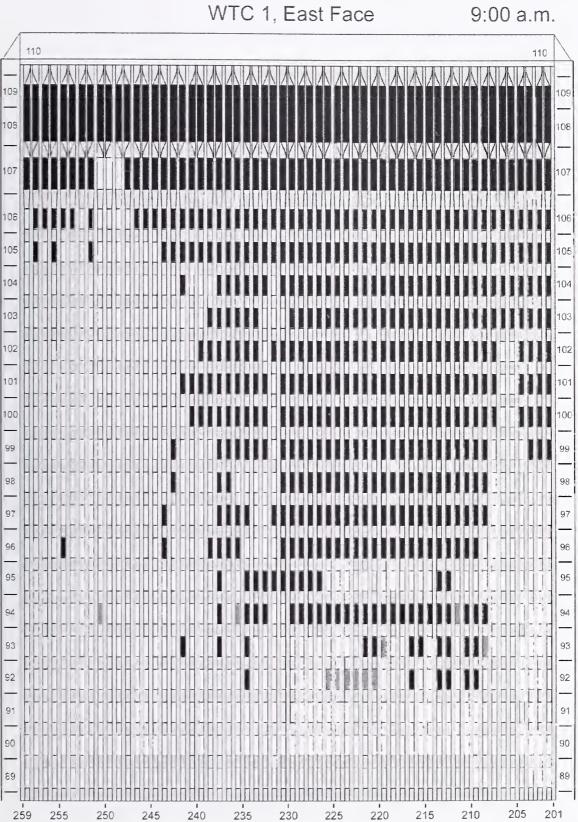
Figure D-9. Diagram of the east face of WTC 1 for floors 89 to 110 at 9:00 a.m. showing the condition of windows and locations of fires.

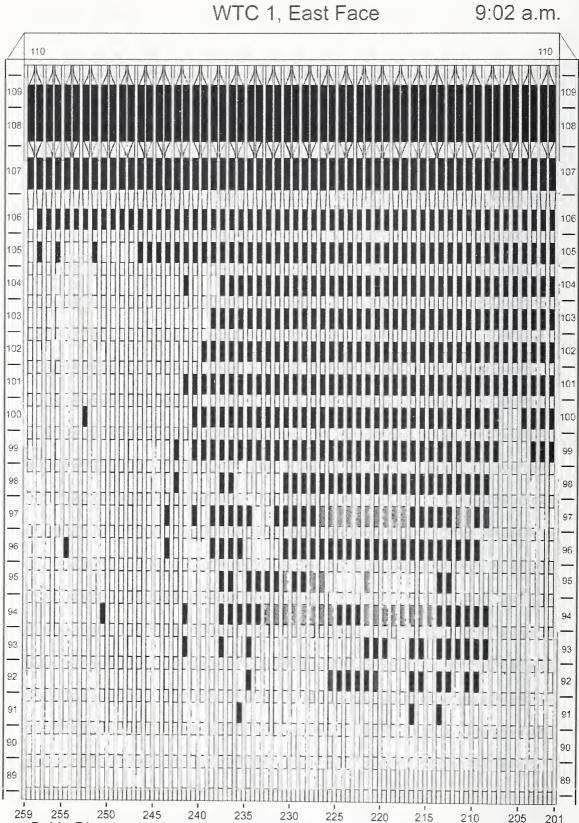
Figure D-10. Diagram of the east face of WTC 1 for floors 89 to 110 at 9:00 a.m. showing windows where smoke was observed and those that were hidden from view.

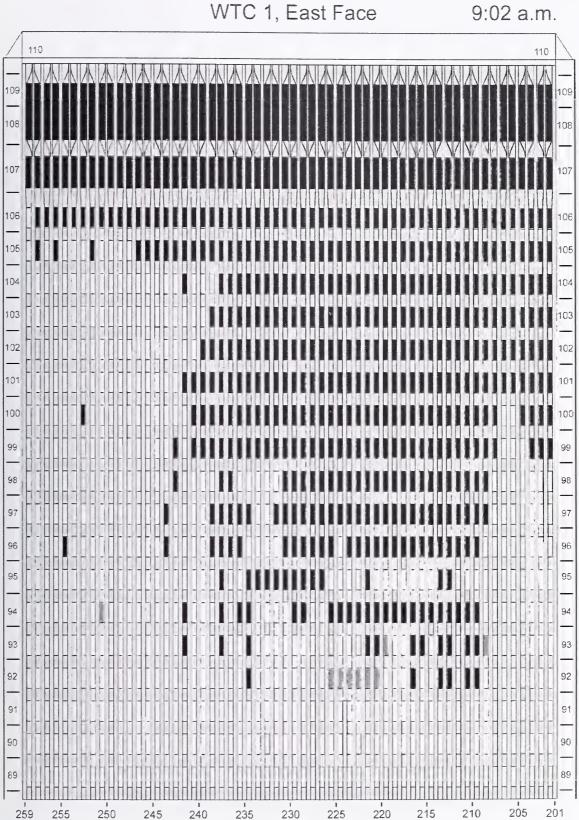
Figure D-11. Diagram of the east face of WTC 1 for floors 89 to 110 at 9:02 a.m. showing the condition of windows and locations of fires.

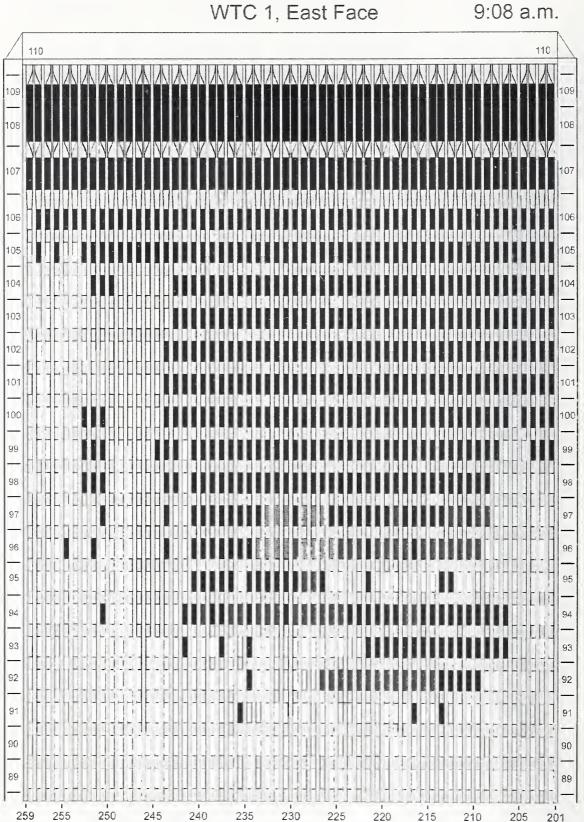
Figure D-13. Diagram of the east face of WTC 1 for floors 89 to 110 at 9:08 a.m. showing the condition of windows and locations of fires.

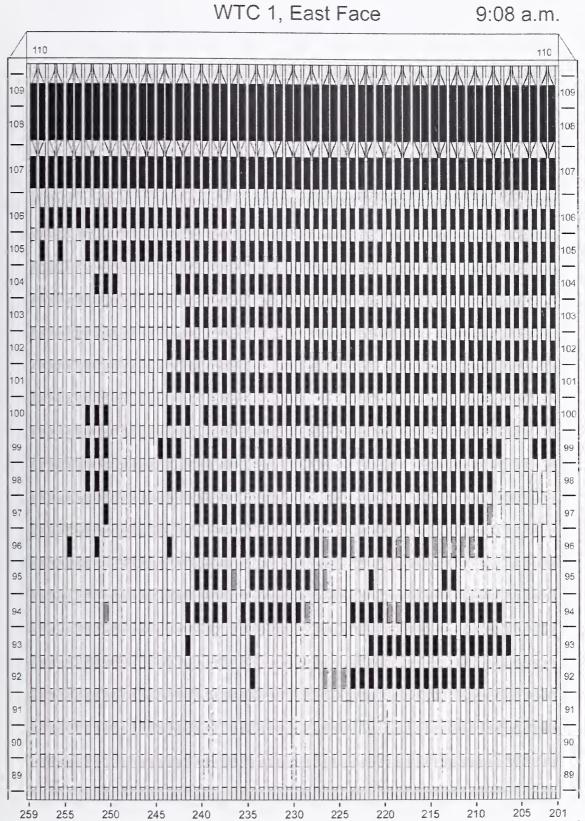
Figure D-14. Diagram of the east face of WTC 1 for floors 89 to 110 at 9:08 a.m. showing windows where smoke was observed and those that were hidden from view.

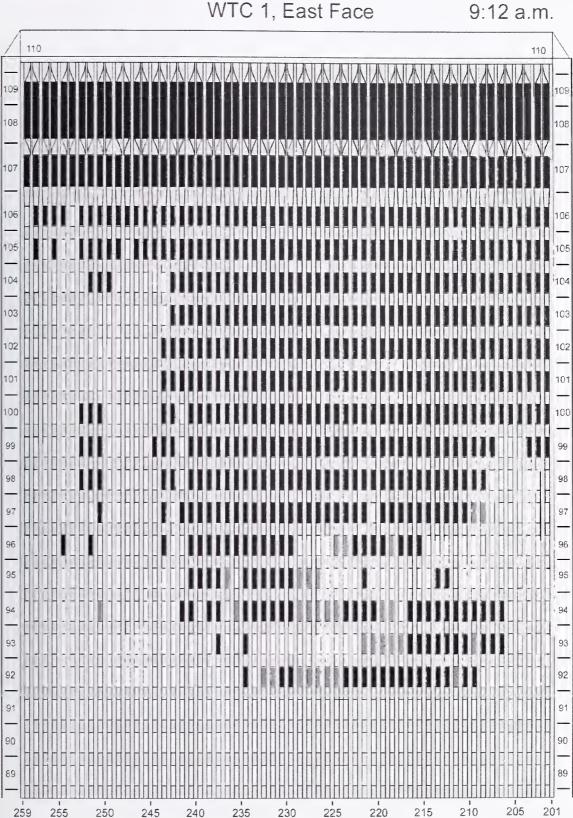
Figure D-15. Diagram of the east face of WTC 1 for floors 89 to 110 at 9:12 a.m. showing the condition of windows and locations of fires.

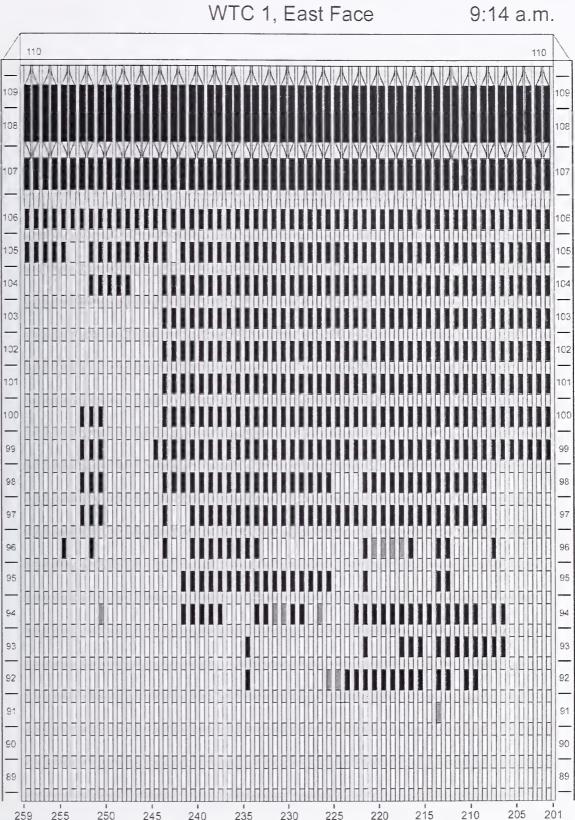
Figure D-17. Diagram of the east face of WTC 1 for floors 89 to 110 at 9:14 a.m. showing the condition of windows and locations of fires.

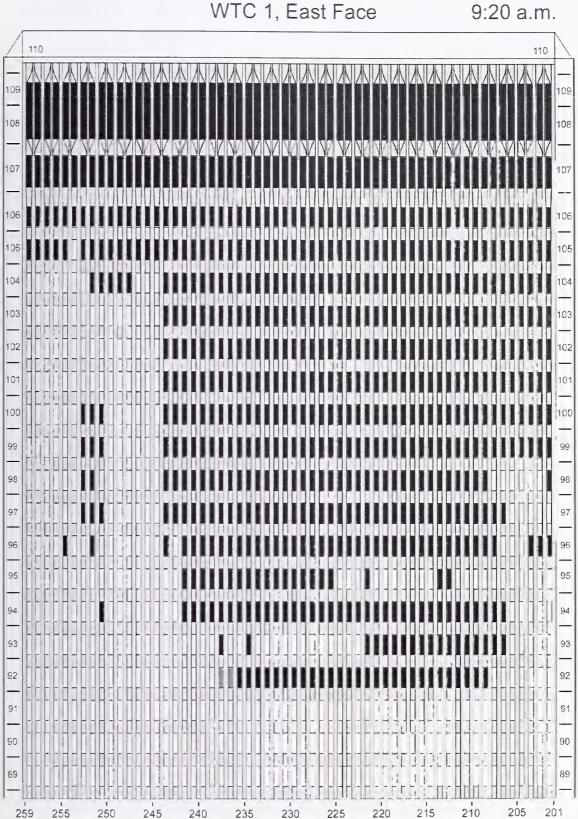
Figure D-19. Diagram of the east face of WTC 1 for floors 89 to 110 at 9:20 a.m. showing the condition of windows and locations of fires.

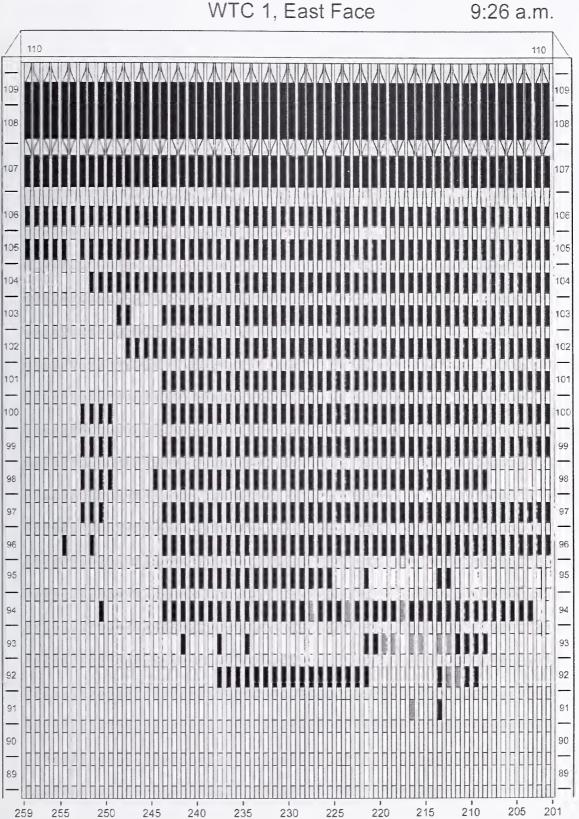
Figure D-21. Diagram of the east face of WTC 1 for floors 89 to 110 at 9:26 a.m. showing the condition of windows and locations of fires.

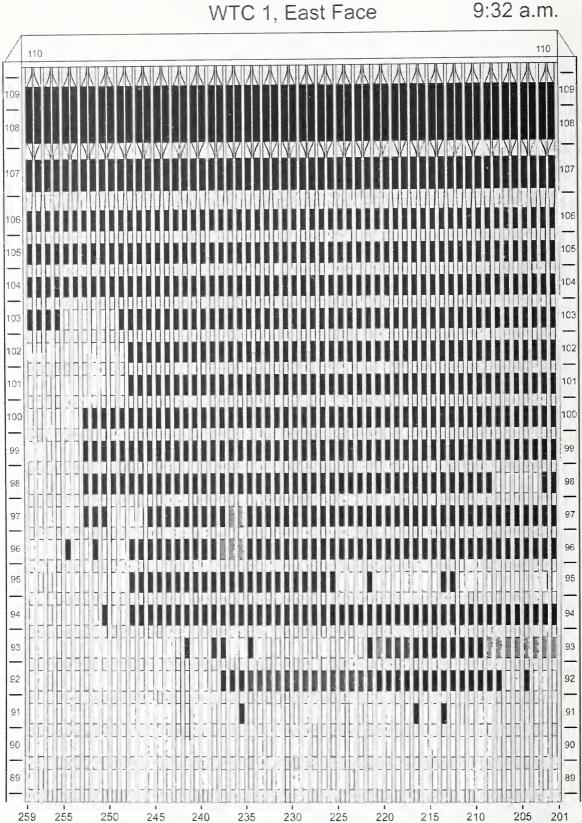
Figure D-22. Diagram of the east face of WTC 1 for floors 89 to 110 at 9:26 a.m. showing windows where smoke was observed and those that were hidden from view.

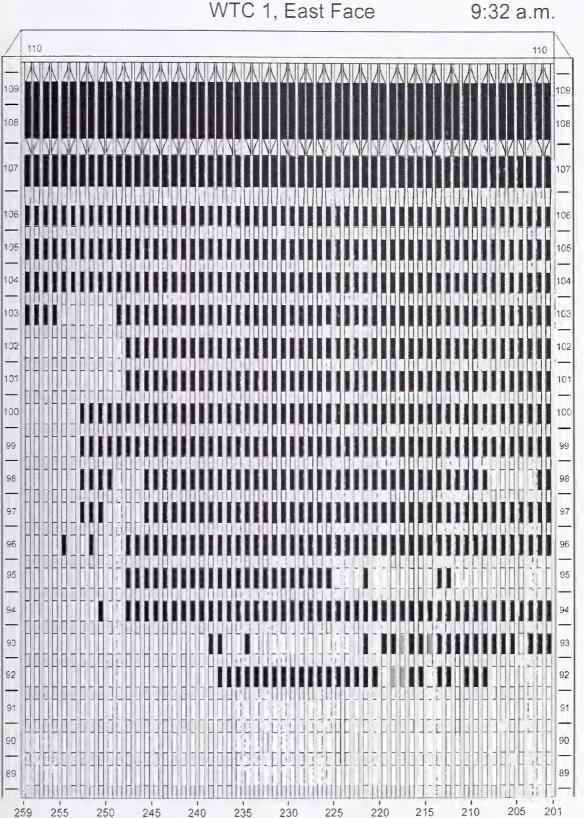
Figure D-23. Diagram of the east face of WTC 1 for floors 89 to 110 at 9:32 a.m. showing the condition of windows and locations of fires.

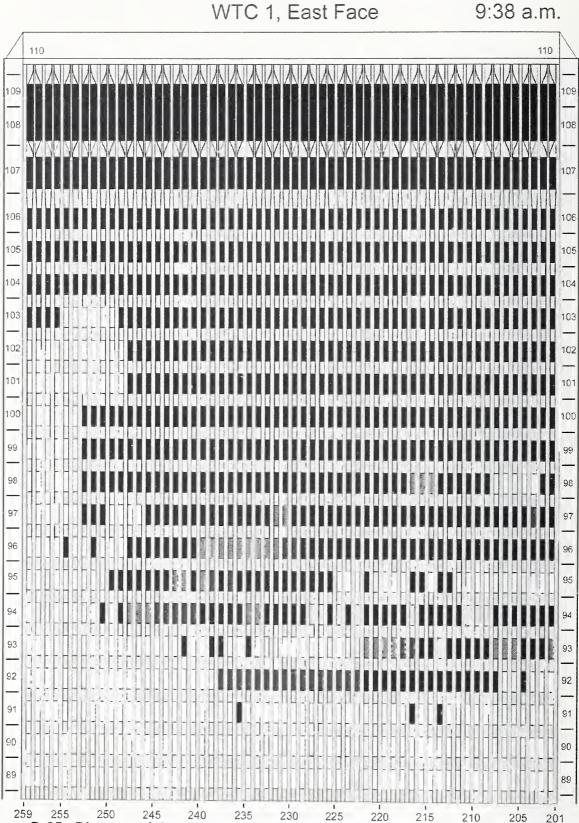
Figure D-24. Diagram of the east face of WTC 1 for floors 89 to 110 at 9:32 a.m. showing windows where smoke was observed and those that were hidden from view.

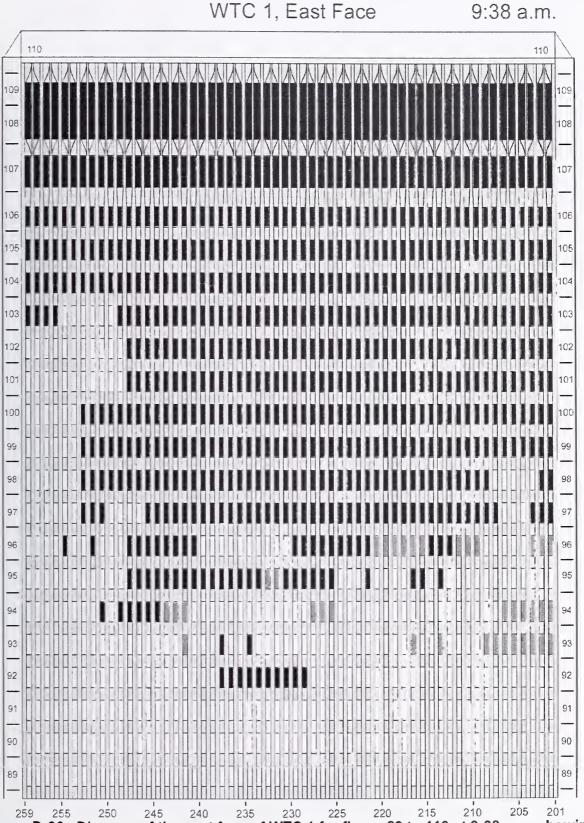
Figure D-25. Diagram of the east face of WTC 1 for floors 89 to 110 at 9:38 a.m. showing the condition of windows and locations of fires.

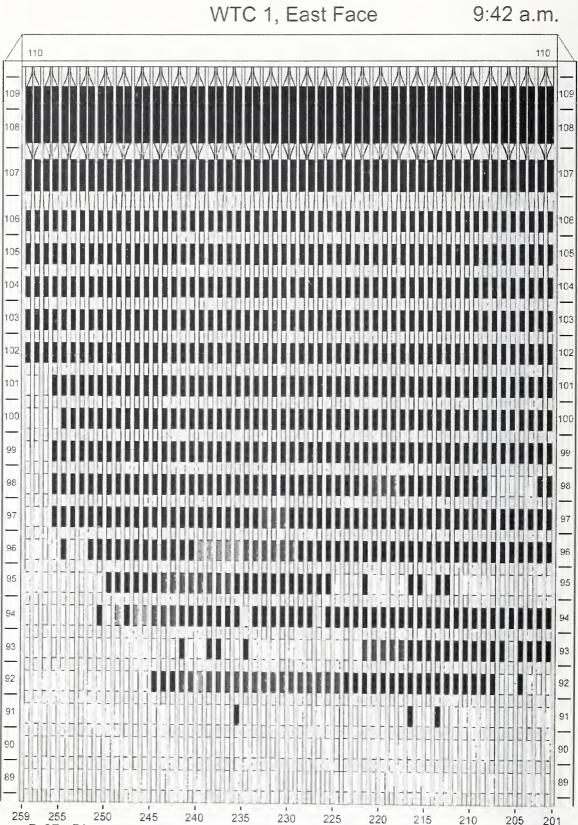
Figure D-26. Diagram of the east face of WTC 1 for floors 89 to 110 at 9:38 a.m. showing windows where smoke was observed and those that were hidden from view.

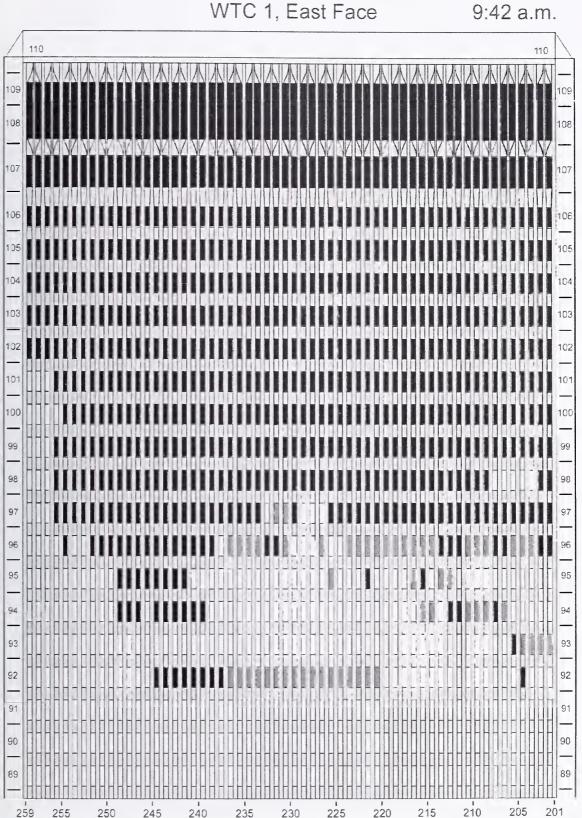
Figure D-27. Diagram of the east face of WTC 1 for floors 89 to 110 at 9:42 a.m. showing the condition of windows and locations of fires.

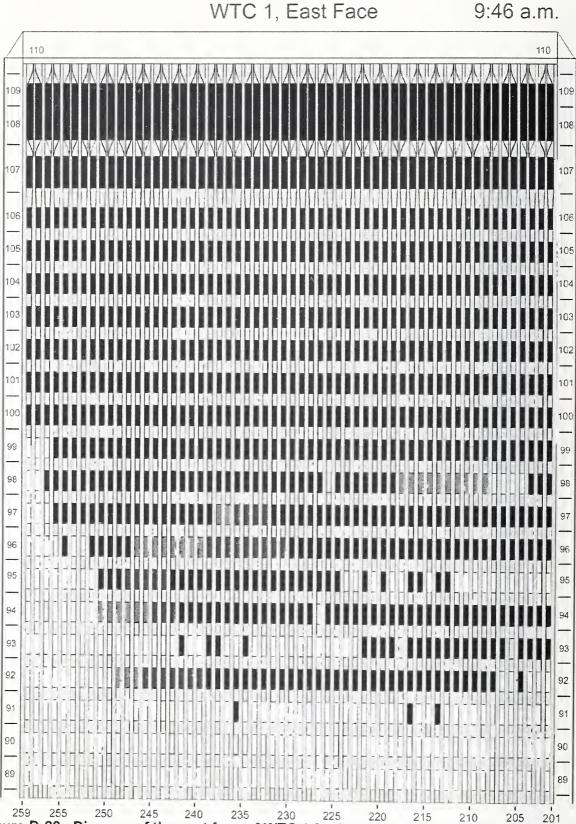
Figure D-28. Diagram of the east face of WTC 1 for floors 89 to 110 at 9:42 a.m. showing windows where smoke was observed and those that were hidden from view.

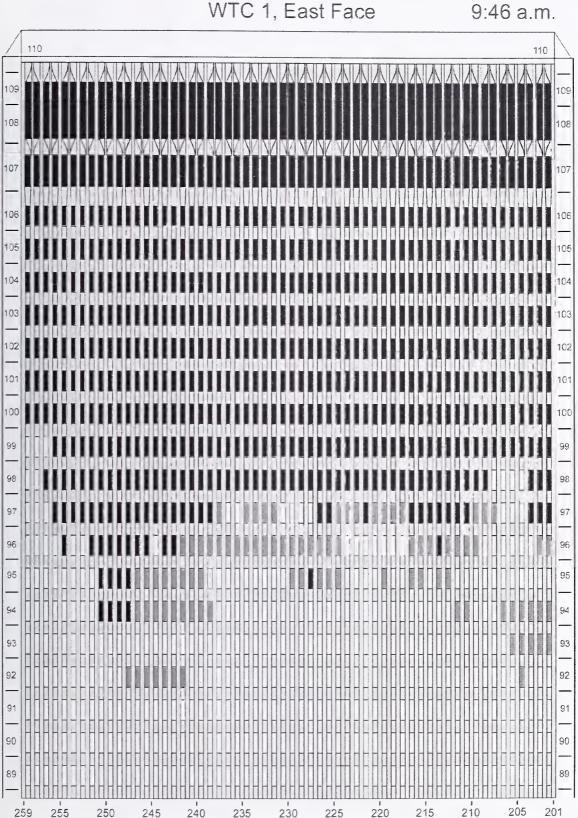
Figure D-29. Diagram of the east face of WTC 1 for floors 89 to 110 at 9:46 a.m. showing the condition of windows and locations of fires.

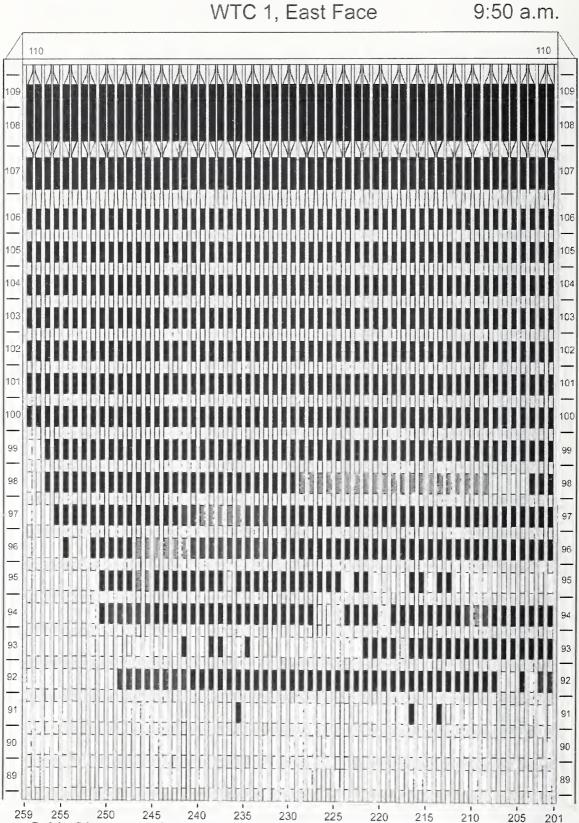
Figure D-30. Diagram of the east face of WTC 1 for floors 89 to 110 at 9:46 a.m. showing windows where smoke was observed and those that were hidden from view.

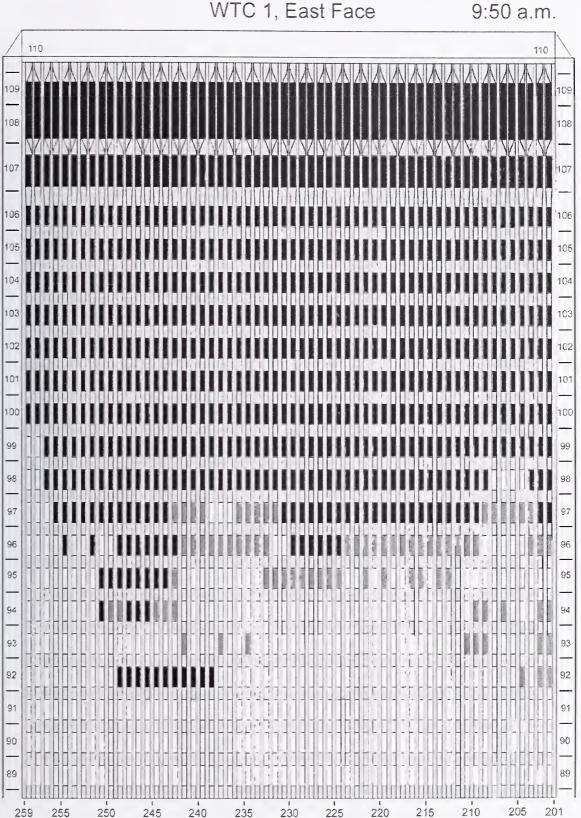
Figure D-31. Diagram of the east face of WTC 1 for floors 89 to 110 at 9:50 a.m. showing the condition of windows and locations of fires.

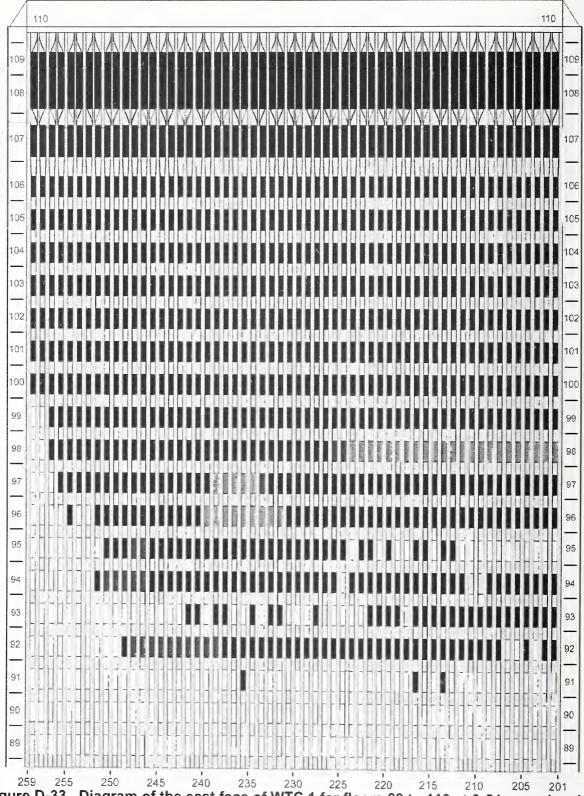
Figure D-33. Diagram of the east face of WTC 1 for floors 89 to 110 at 9:54 a.m. showing the condition of windows and locations of fires.

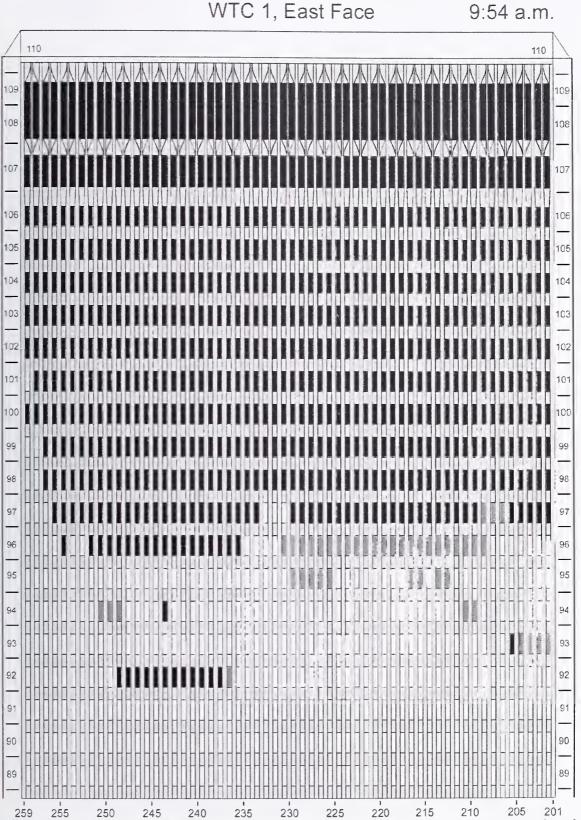
Figure D-34. Diagram of the east face of WTC 1 for floors 89 to 110 at 9:54 a.m. showing windows where smoke was observed and those that were hidden from view.

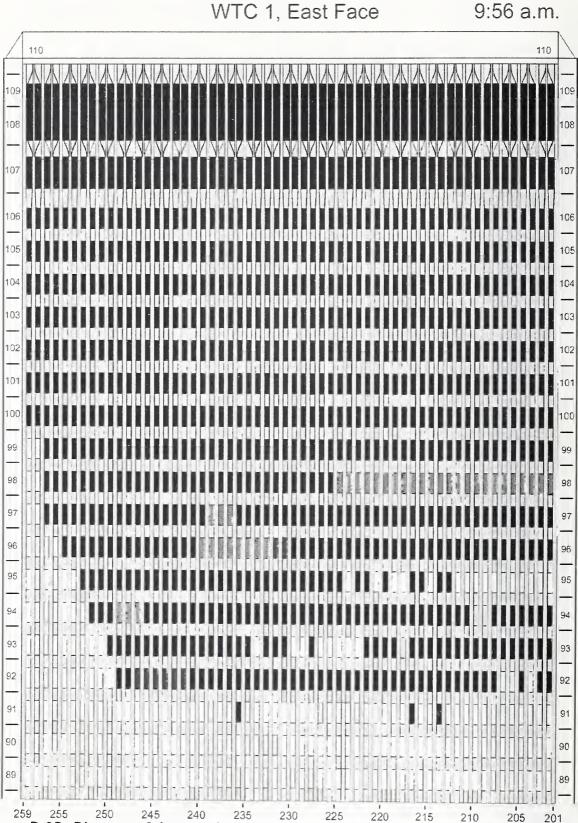
Figure D-35. Diagram of the east face of WTC 1 for floors 89 to 110 at 9:56 a.m. showing the condition of windows and locations of fires.

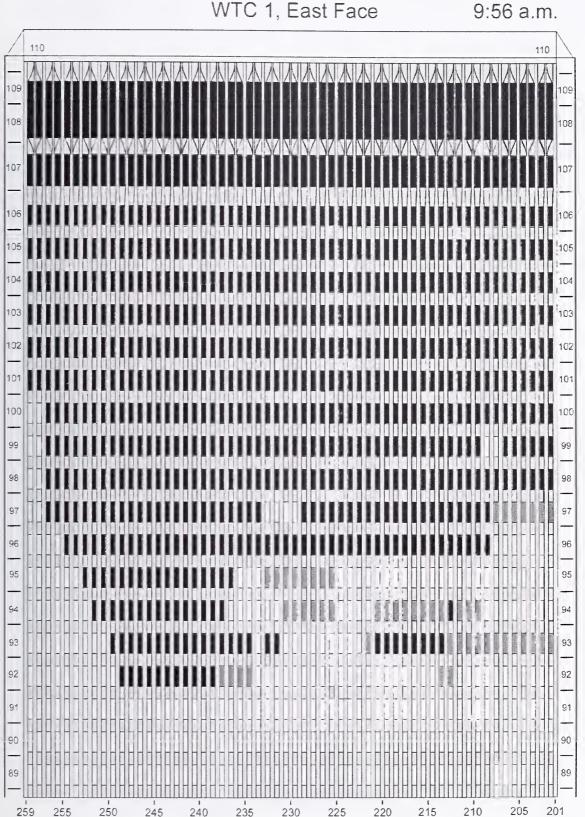
Figure D-36. Diagram of the east face of WTC 1 for floors 89 to 110 at 9:56 a.m. showing windows where smoke was observed and those that were hidden from view.

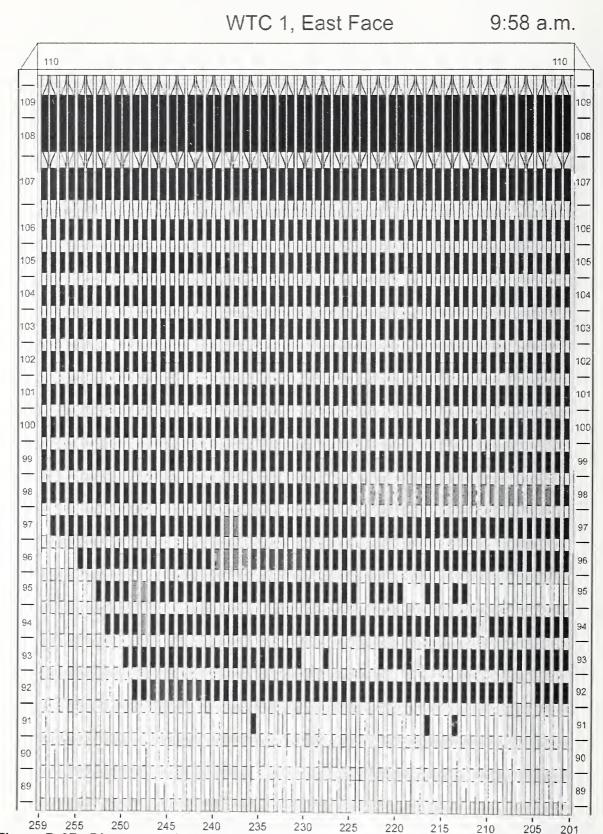
Figure D-37. Diagram of the east face of WTC 1 for floors 89 to 110 at 9:58 a.m. showing the condition of windows and locations of fires.

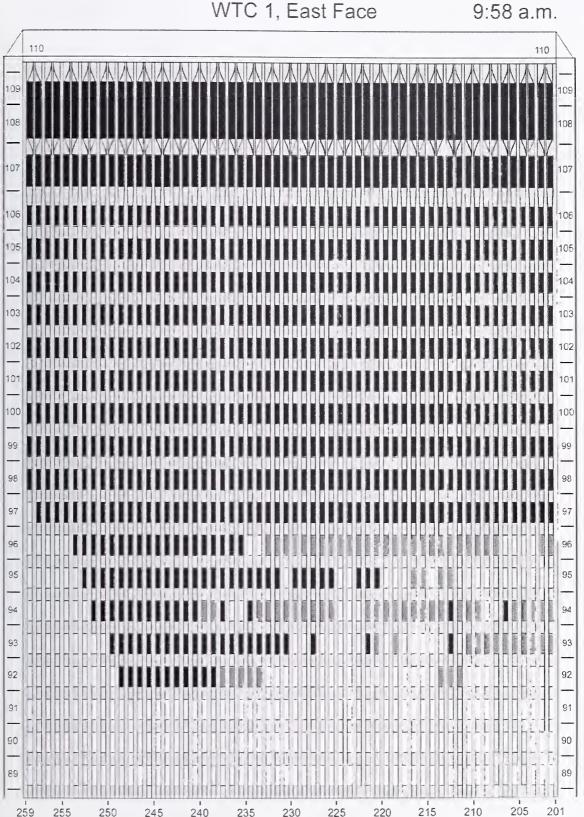
Figure D-38. Diagram of the east face of WTC 1 for floors 89 to 110 at 9:58 a.m. showing windows where smoke was observed and those that were hidden from view.

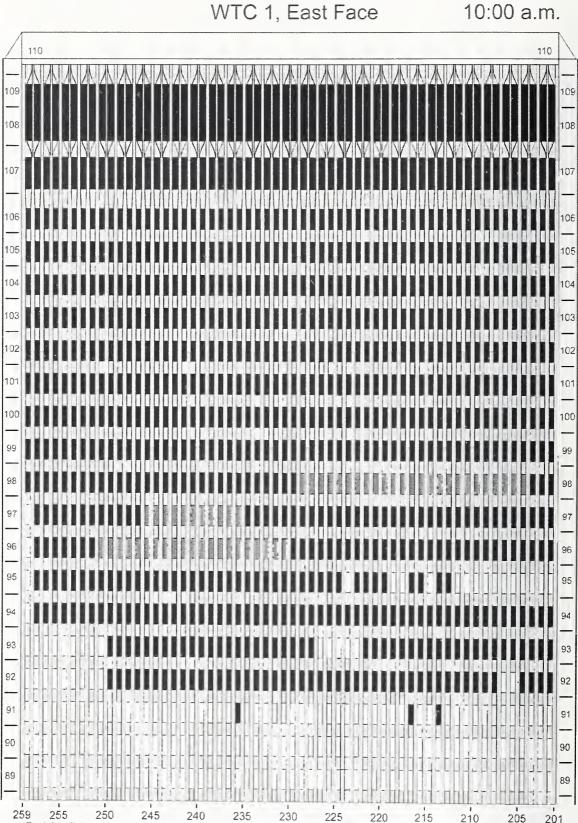
Figure D-39. Diagram of the east face of WTC 1 for floors 89 to 110 at 10:00 a.m. showing the condition of windows and locations of fires.

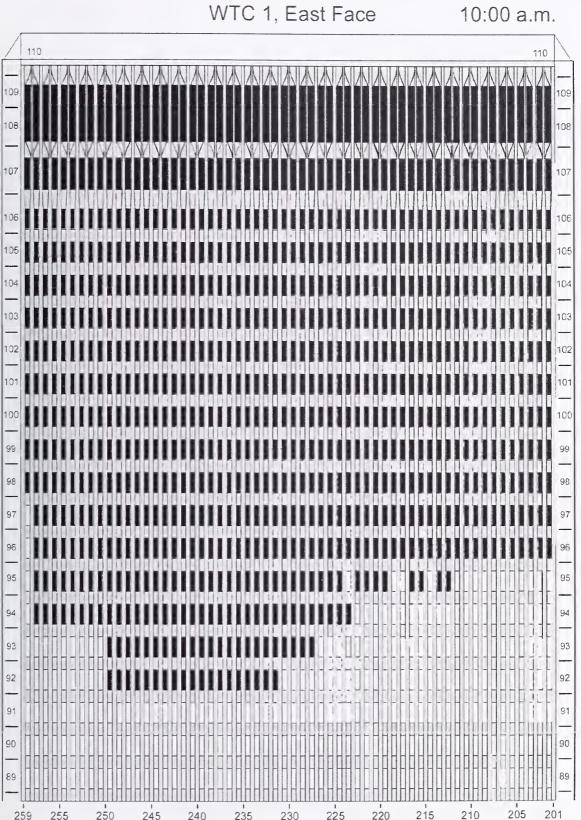
Figure D-40. Diagram of the east face of WTC 1 for floors 89 to 110 at 10:00 a.m. showing windows where smoke was observed and those that were hidden from view.

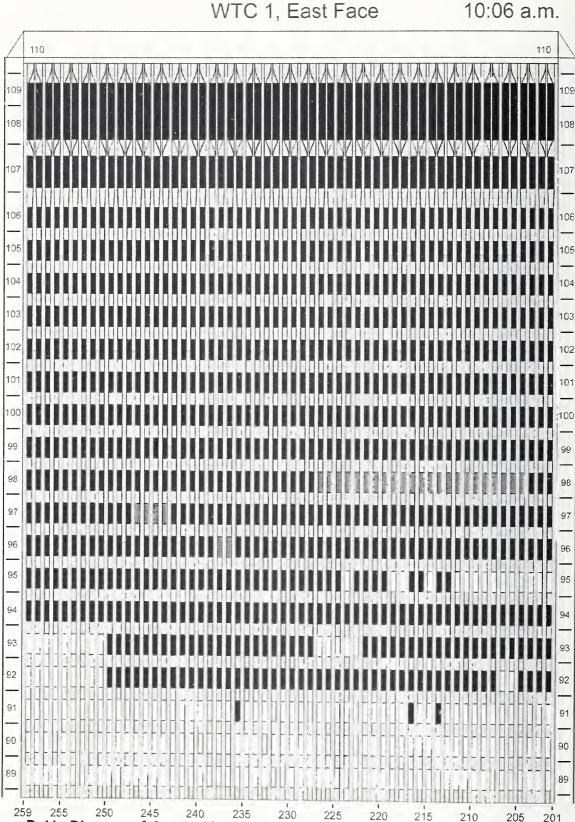
Figure D-41. Diagram of the east face of WTC 1 for floors 89 to 110 at 10:06 a.m. showing the condition of windows and locations of fires.

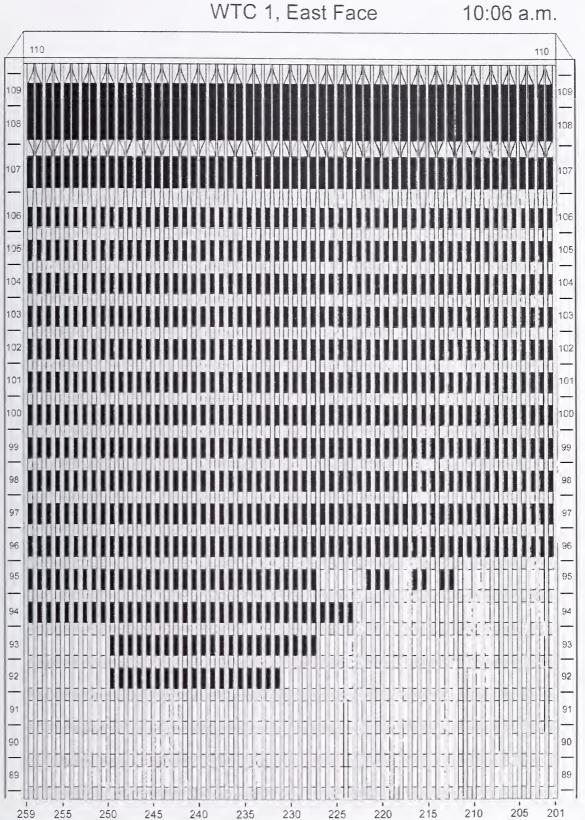
Figure D-42. Diagram of the east face of WTC 1 for floors 89 to 110 at 10:06 a.m. showing windows where smoke was observed and those that were hidden from view.

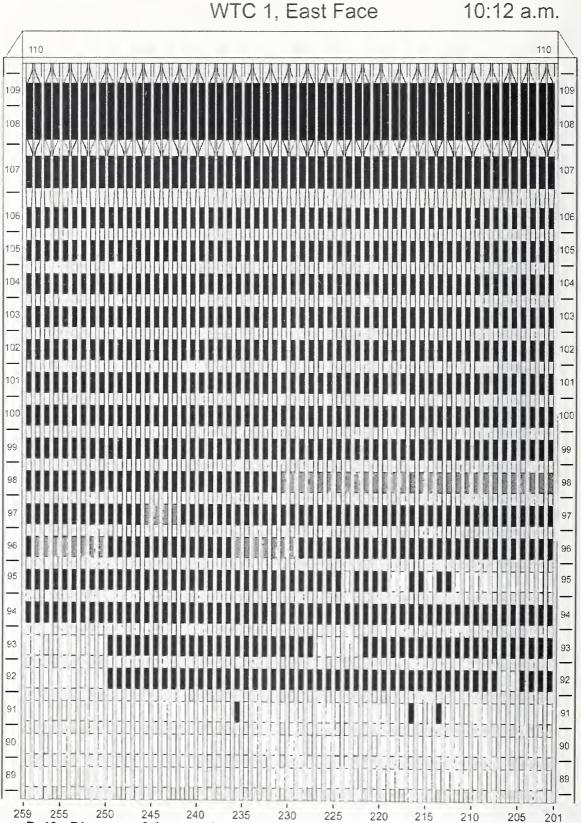
Figure D-43. Diagram of the east face of WTC 1 for floors 89 to 110 at 10:12 a.m. showing the condition of windows and locations of fires.

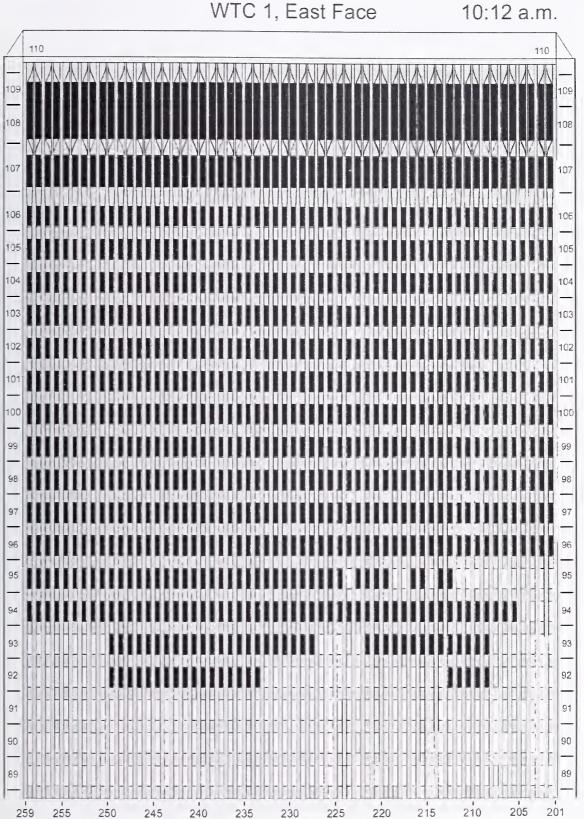
Figure D-44. Diagram of the east face of WTC 1 for floors 89 to 110 at 10:12 a.m. showing windows where smoke was observed and those that were hidden from view.

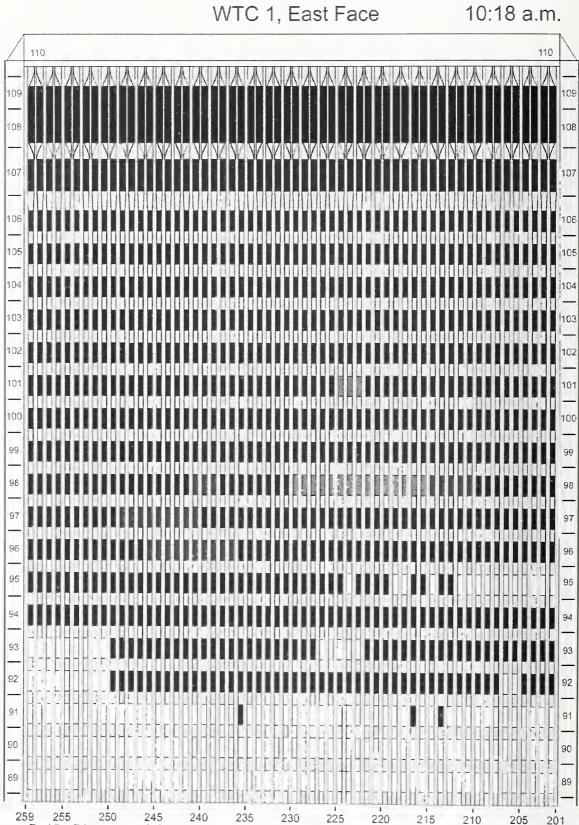
Figure D-45. Diagram of the east face of WTC 1 for floors 89 to 110 at 10:18 a.m. showing the condition of windows and locations of fires.

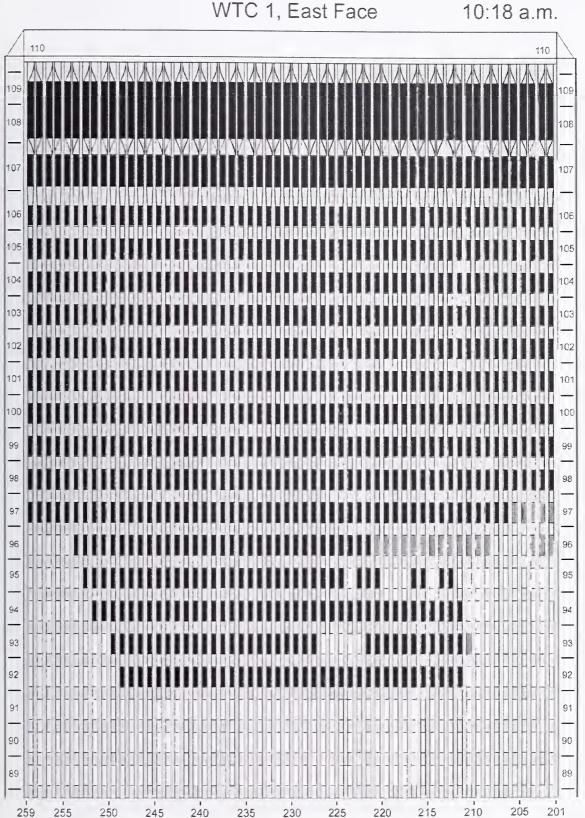
Figure D-46. Diagram of the east face of WTC 1 for floors 89 to 110 at 10:18 a.m. showing windows where smoke was observed and those that were hidden from view.

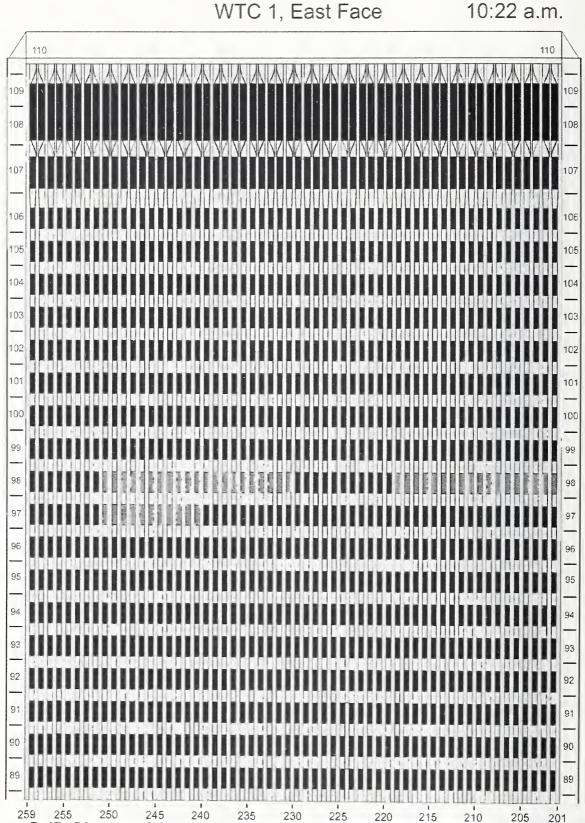
Figure D-47. Diagram of the east face of WTC 1 for floors 89 to 110 at 10:22 a.m. showing the condition of windows and locations of fires.

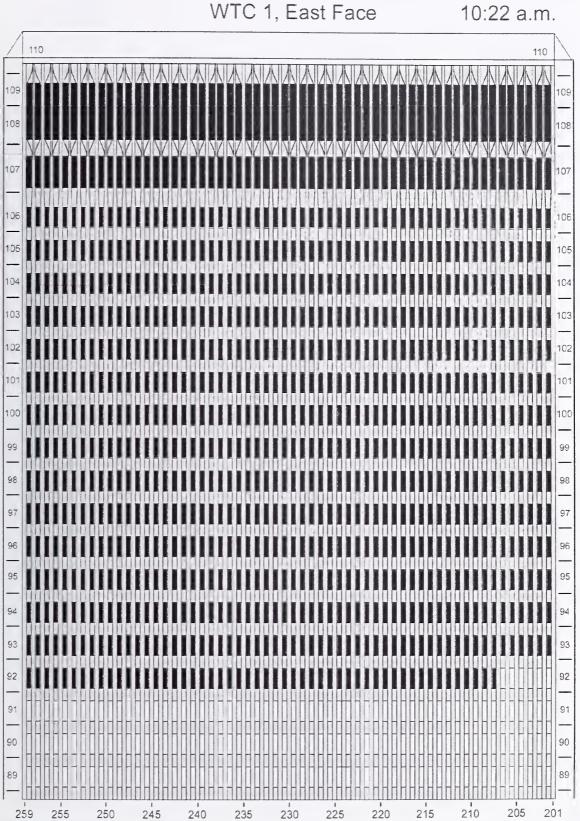
Figure D- 48. Diagram of the east face of WTC 1 for floors 89 to 110 at 10:22 a.m. showing windows where smoke was observed and those that were hidden from view.

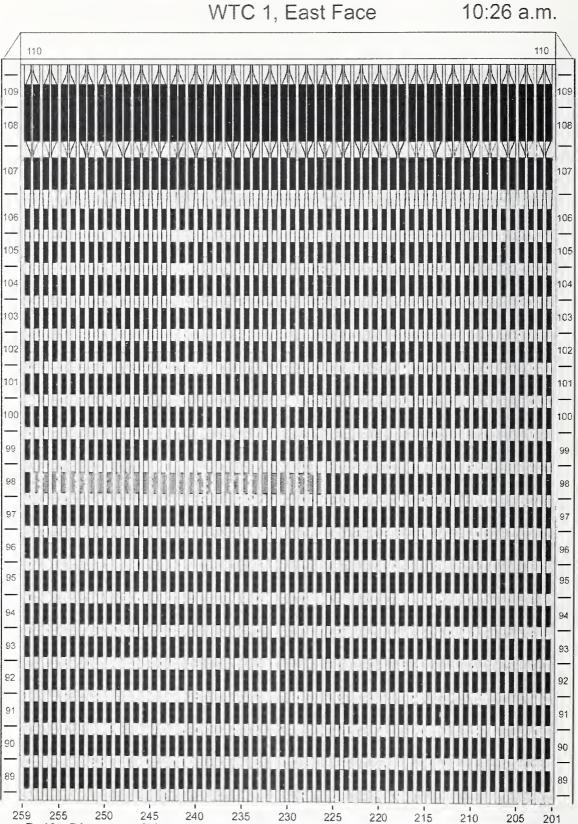
Figure D-49. Diagram of the east face of WTC 1 for floors 89 to 110 at 10:26 a.m. showing the condition of windows and locations of fires.

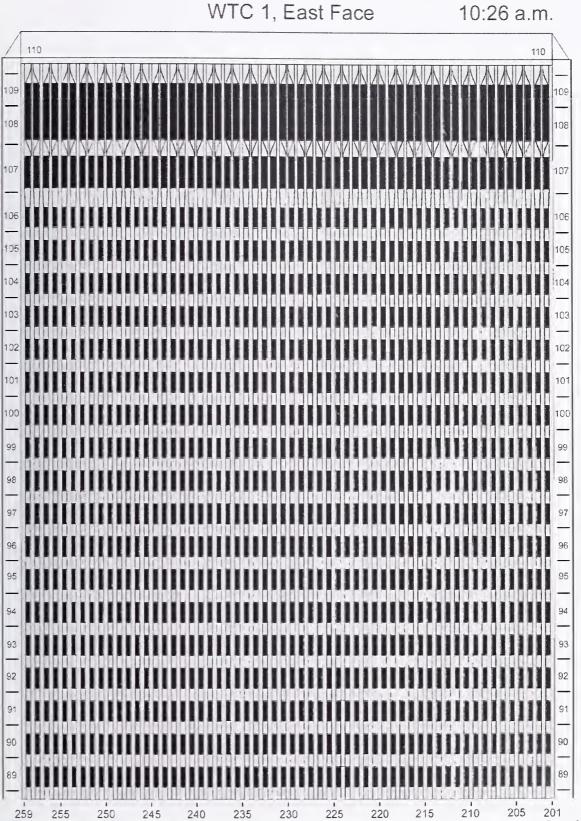
Figure D-50. Diagram of the east face of WTC 1 for floors 89 to 110 at 10:26 a.m. showing windows where smoke was observed and those that were hidden from view.

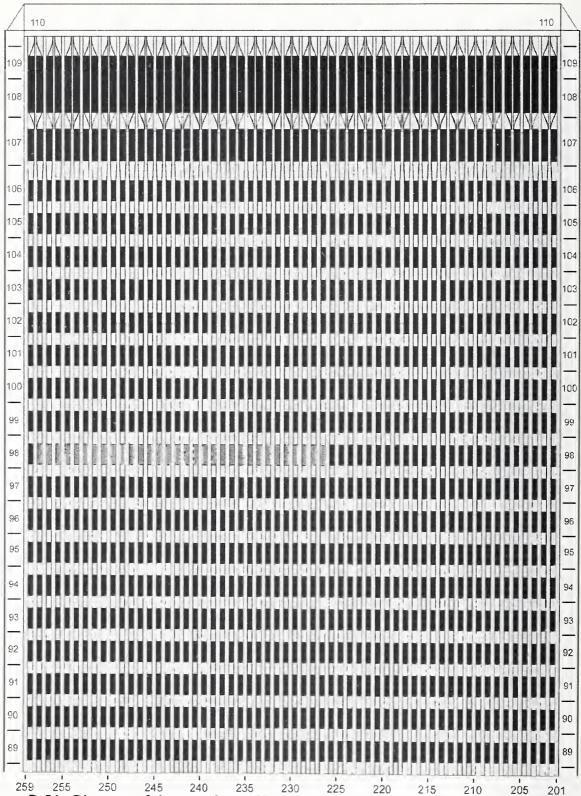
Figure D-51. Diagram of the east face of WTC 1 for floors 89 to 110 at 10:28 a.m. showing the condition of windows and locations of fires.

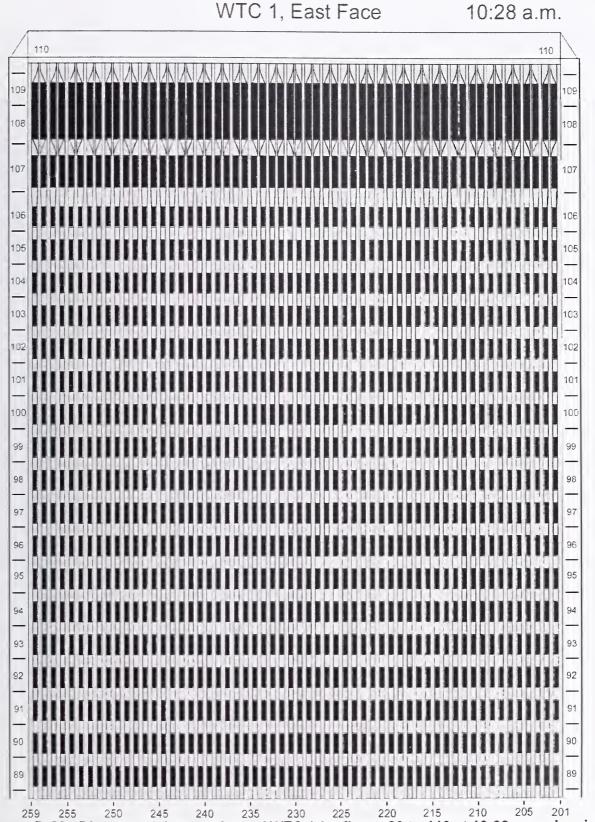
Figure D-52. Diagram of the east face of WTC 1 for floors 89 to 110 at 10:28 a.m. showing windows where smoke was observed and those that were hidden from view.
